The following is a description of the ongoing Emergency Stream bank and Greenway Trail Erosion Repair along the Herring Run. The repair work starts just south of the Harford Road Bridge to the pedestrian bridge. The work is emergency temporary repair; not a long term fix.

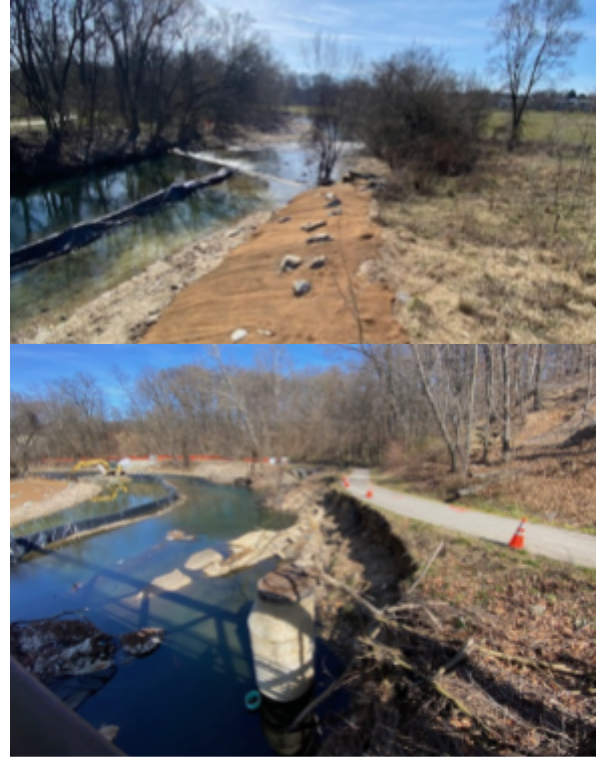
A view from pedestrian bridge of work area

It is being done in two stages. First, a dam of rocks and poly material was installed to divert water from the far bank (Hooper side). A temporary bridge was installed across the run. This enabled equipment to get in and re-slope the bank and cover it with geotechnical material. Not clear if it will be vegetated as part of the work or if it will be left to re-vegetate without plantings.

The next stage is to stabilize the near bank (Tyndale side) by addressing the mass failure and bank undercutting caused by fluctuations in the stream flow. The stream will be diverted away from this side with a temporary poly wall and diversion dam.

The bank stabilization plan is to use a combination of rock, soil, and bundled vegetative staking. The work will focus on the bank that is south of the Tyndale drainage outfall to the sewer stack near the pedestrian bridge. One complication is a large outcropping of bedrock in the water. Getting the correct bank grade/slope around those immovable rock slabs will be challenging.
